PRODUCT BULLETIN NUMBER: 64

SAFETY ALERT

SUBJECT: **RETRACTION FRAME/ GUIDE RUNNERS**

SERIAL NUMBERS: 135, 136, 137

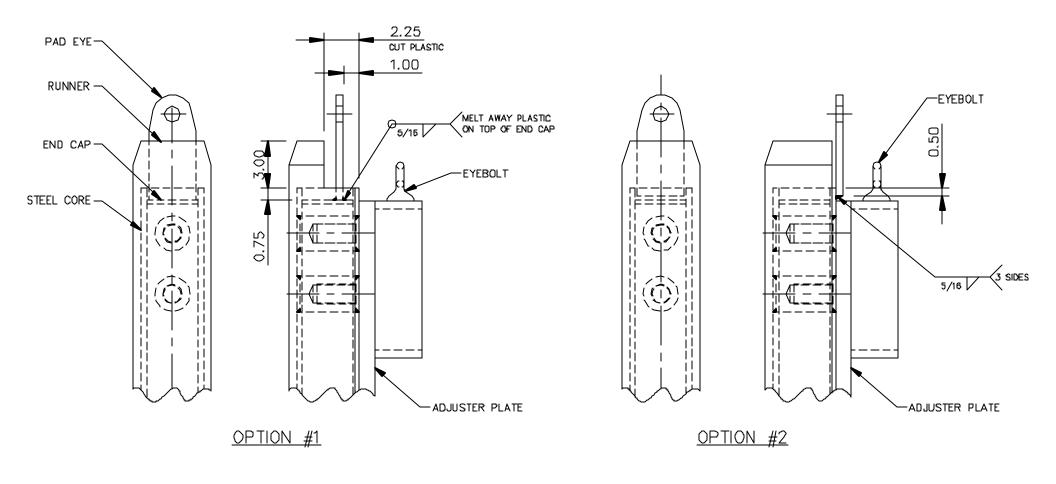
1) Cut off the top 3" of plastic from the top end of each runner. Drill and tap the top end cap of the runners ½".

NOTE: The steel end cap is located approximately 3/4" below the top of the cut runner. Thread a ½" eyebolt into the top of each runner and secure to the evebolt on top of the adjusting plate with \(\frac{1}{4} \).

2) Weld a pad eye to the top of each runner on the face that fits against the adjusting plate. The steel core of the runner extends above the top of the adjusting plate by 3/4". The pad eye should be welded to steel core of the runner at this location. Secure the runners to the eyebolt on top of the adjuster plate with 1/4" wire.
