## **Change Bulletin**

No: CB049 | Rev: 0 | Date: June 13, 2012

Steel Cable Tugger Line to Replace
Cat Line Tugger During Top Drive Rig Up

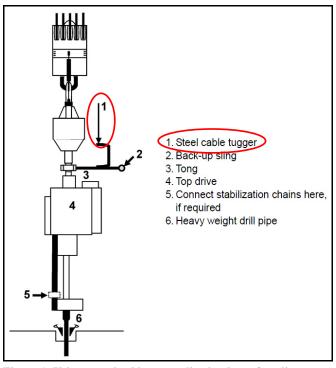
Figure 1: Using a steel cable tugger line in place of cat line tugger

All TESCO Top Drives that are operating in the field or are in the process of being rigged up must replace the cat line tugger with a steel cable tugger line.
